Dear Planning Commission:

Hwy 2W Columbia Co MP 36.5-40.0
Tide Creek Slide

PHOTOGRAPHIC RECORD OF SLIDES

GOBLE - TIDE CREEK SECTION
Columbia River Highway

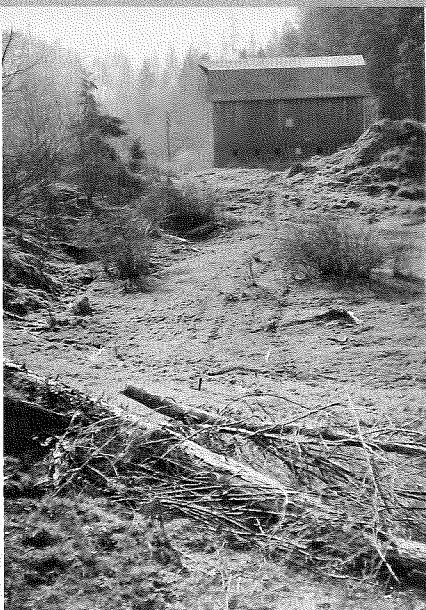
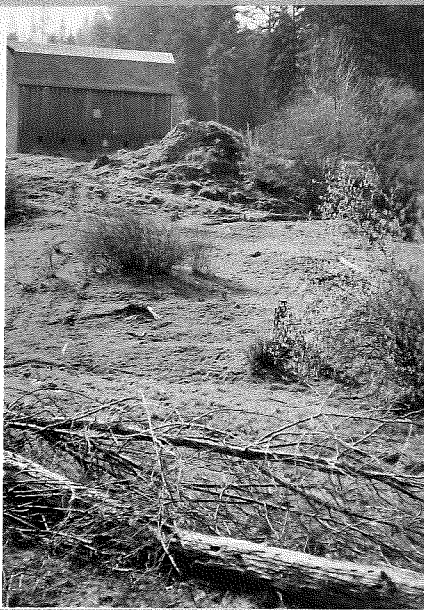
Vide-Creek-Goble Section, Possible Slide at 167+00, 00' to 300'.

Looking West

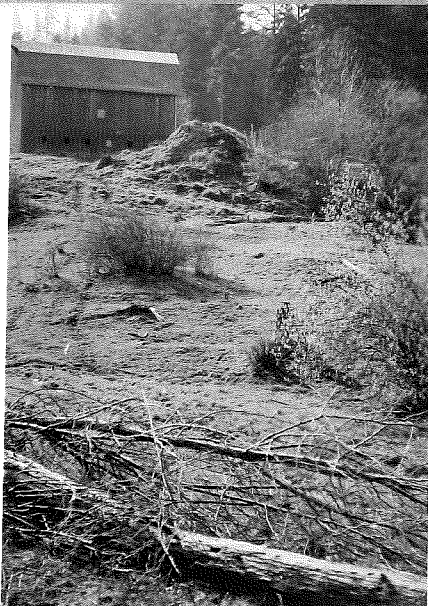
Looking West.

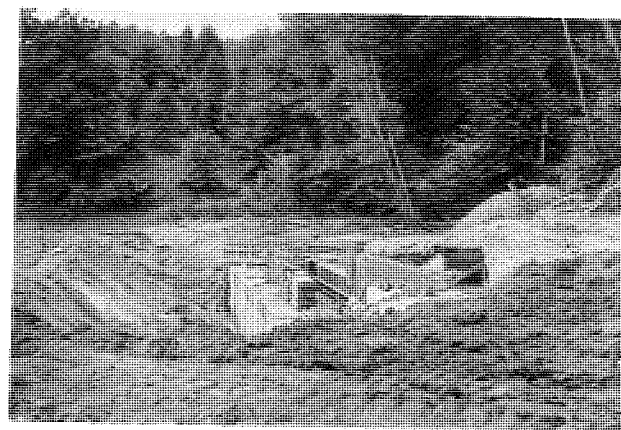
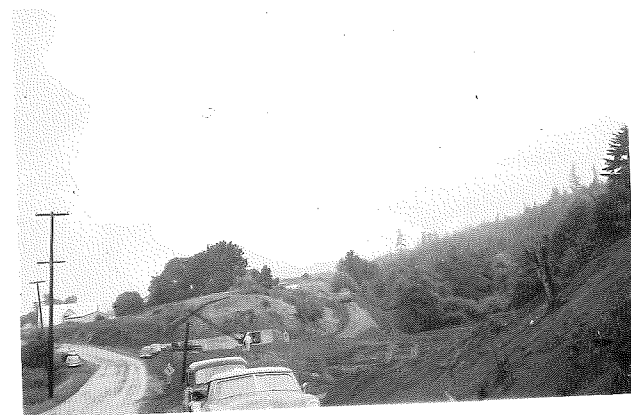
Photographs 1 to 3 are of the Adams quarry, the site of the material used to construct counter balance and rock fills for correcting the Red Barn slide, Big Meadows Ranch slide Lt. 103 to 110 and The Leppin slide Lt. 179 to 185.

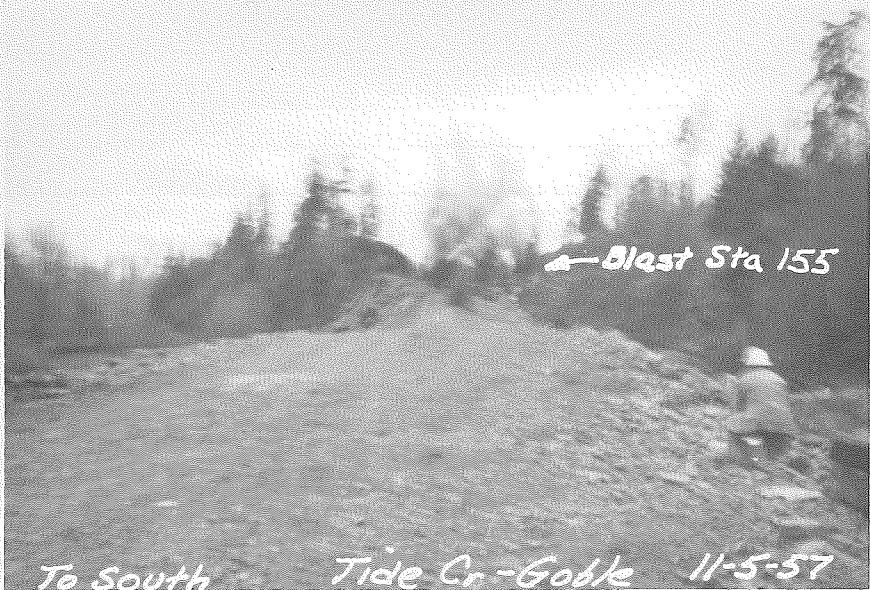
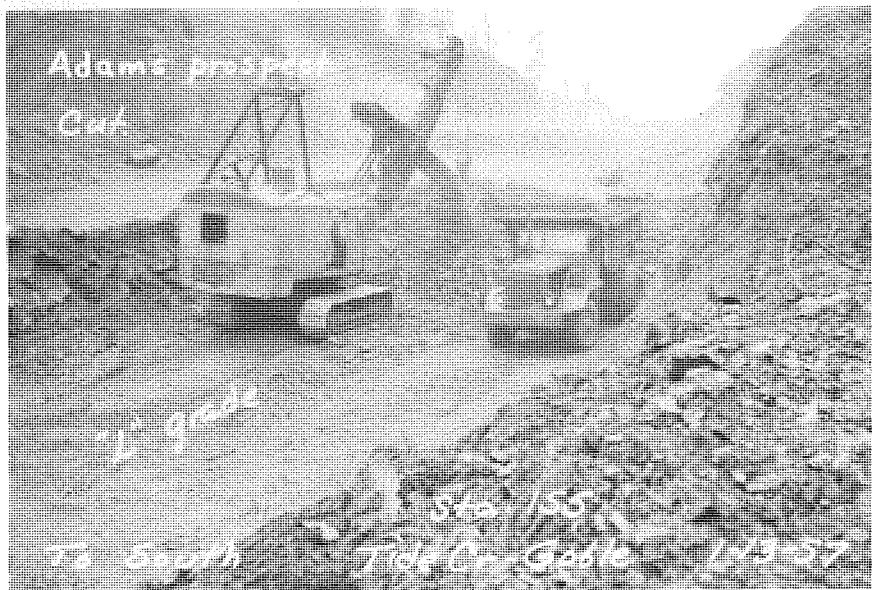
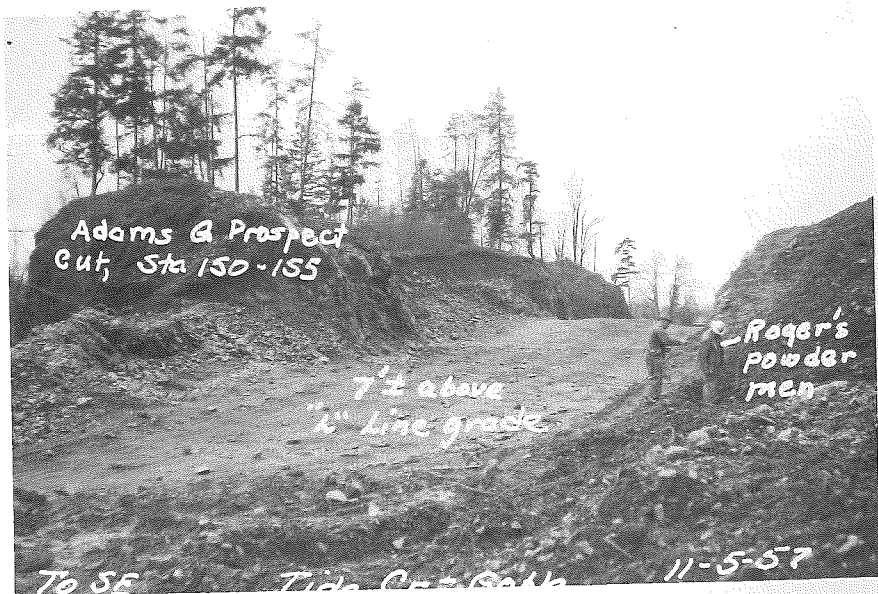
To South Tide Cr-Goble 11-5-57

To South Tide Cr-Goble Sta 155 11-5-57

To SE Tide Cr-Goble 11-5-57

Photographs 1 to 5 show the general limits of the slide area and beginning activities.

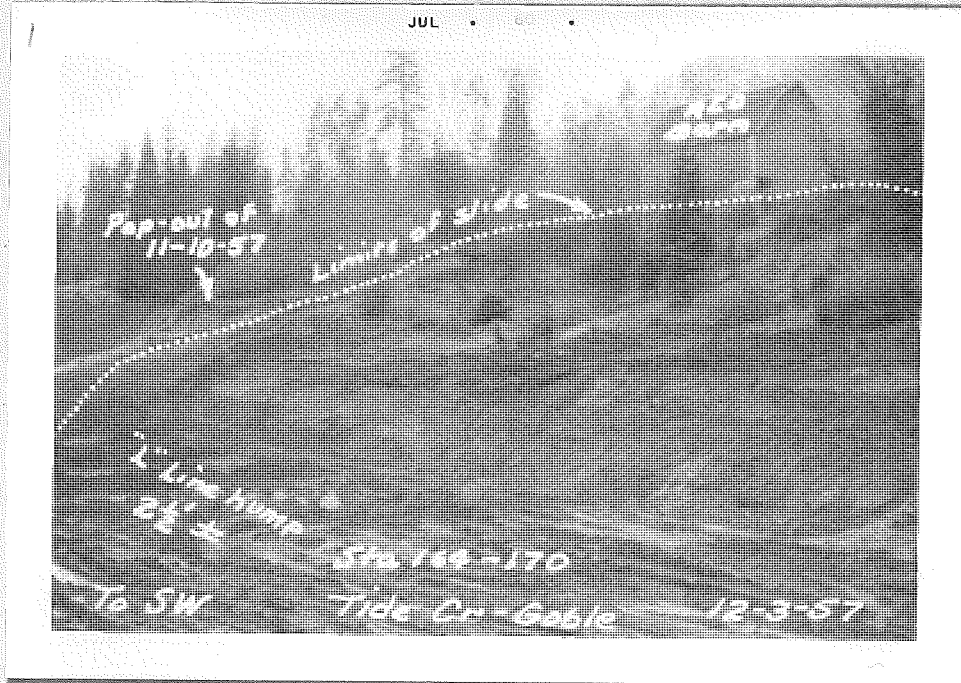
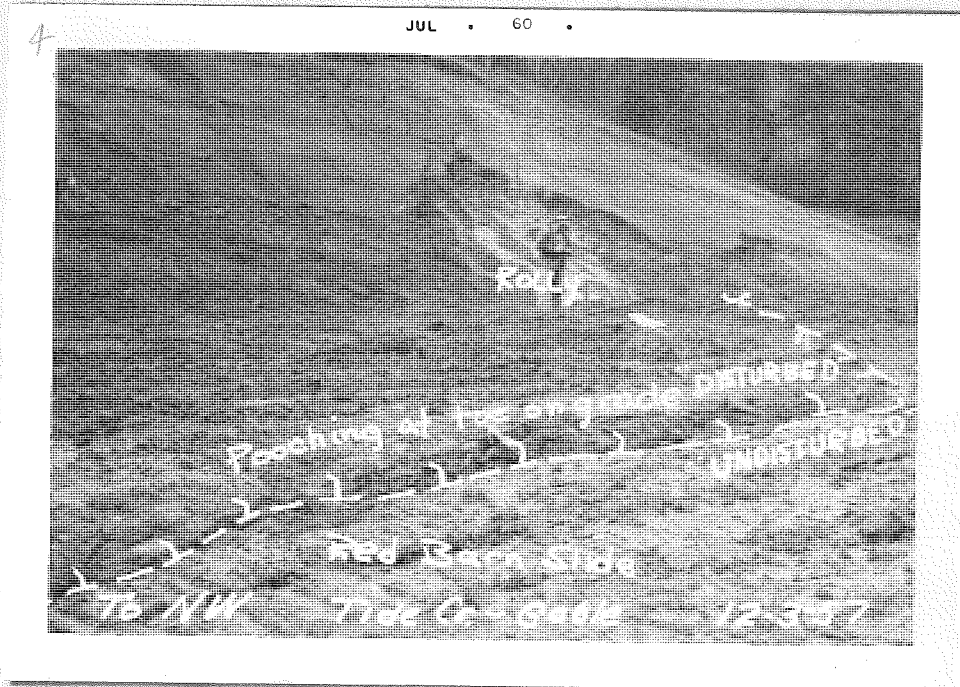
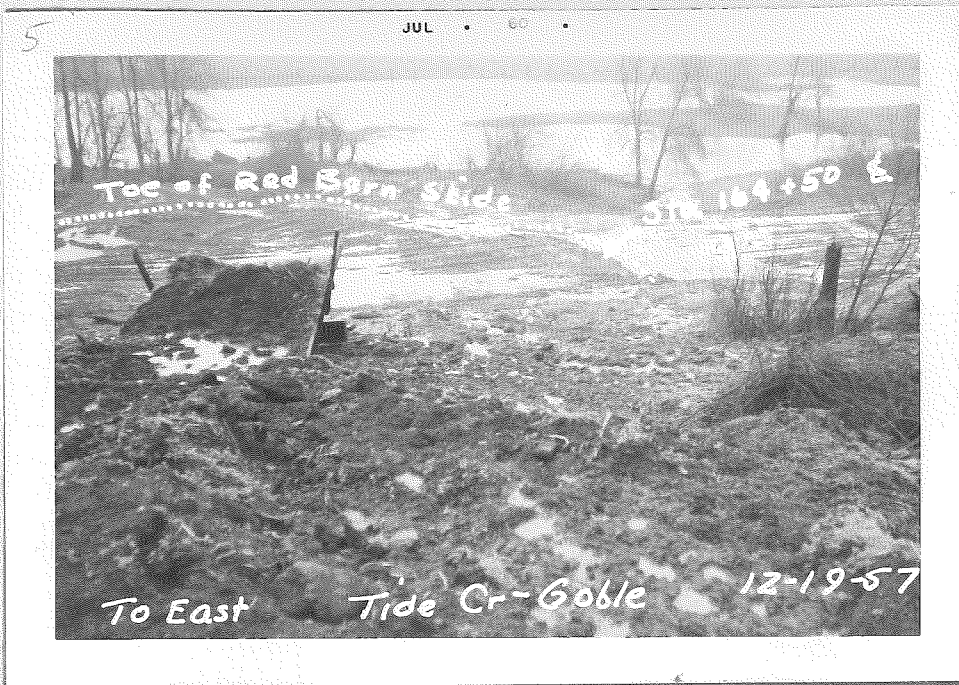
Photographs 6 to 10 show the surface cracks and settlement in the vicinity of the Red Barn.

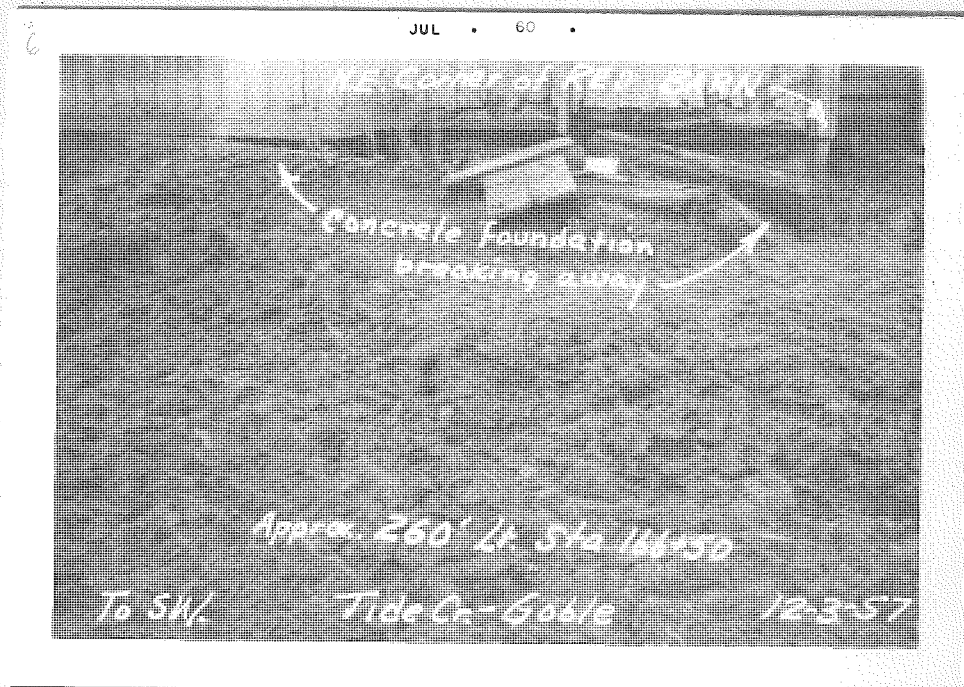
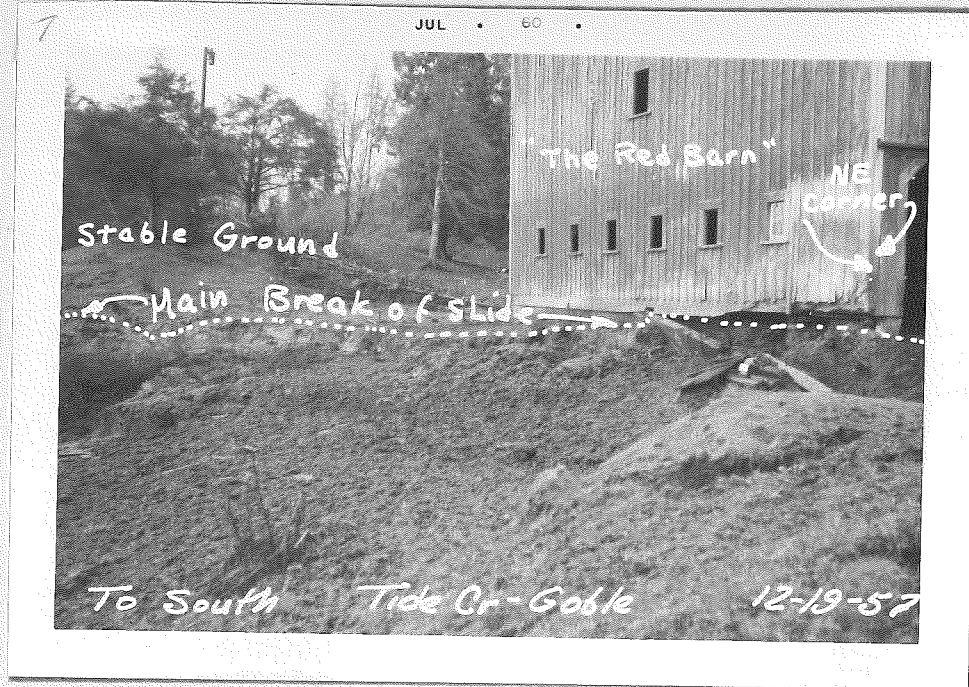
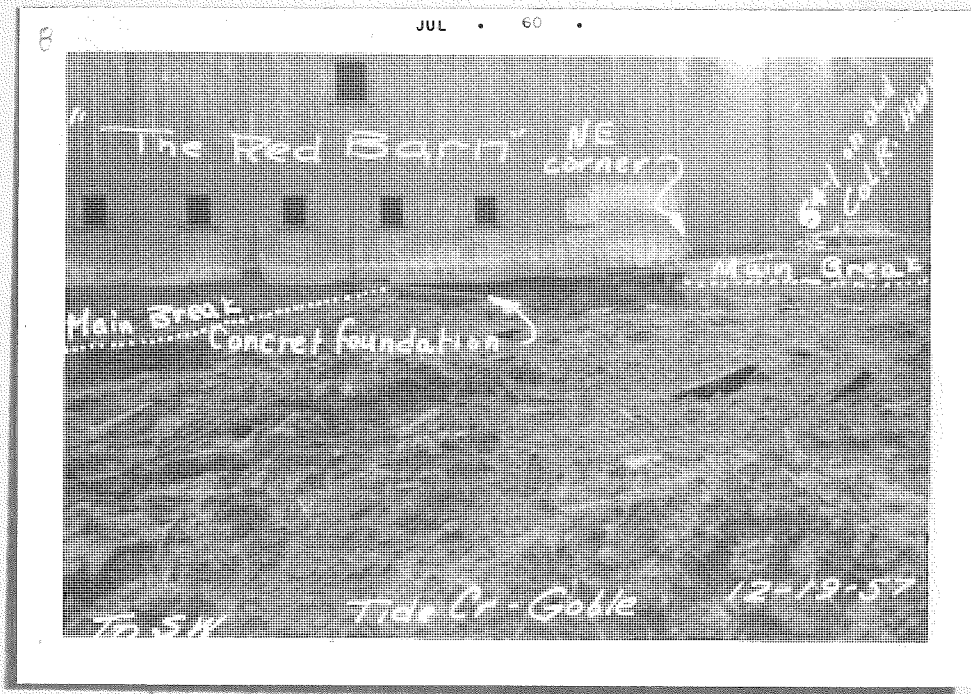
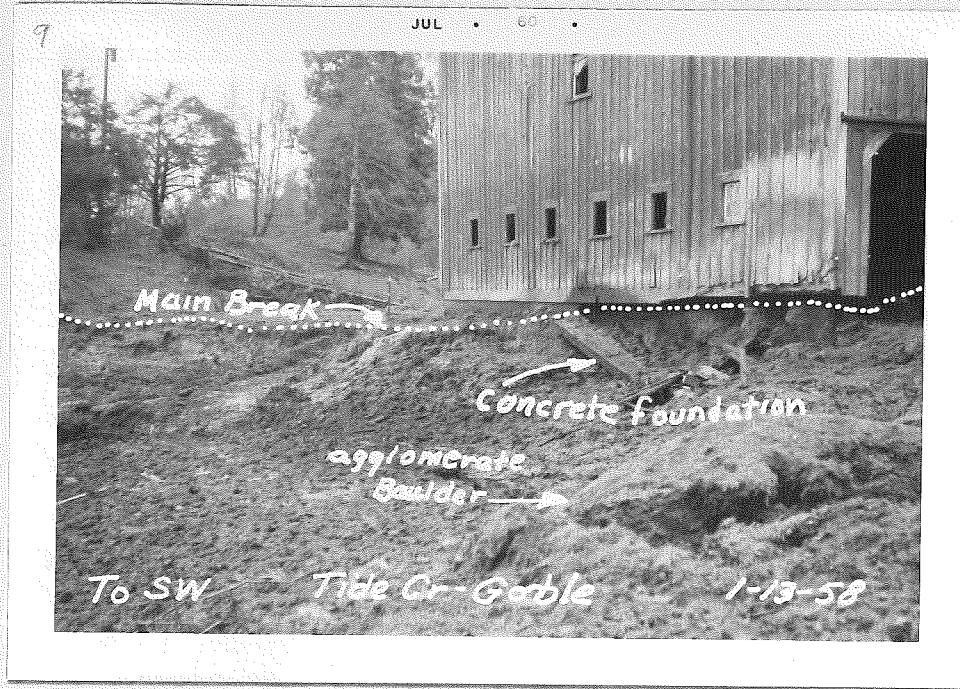
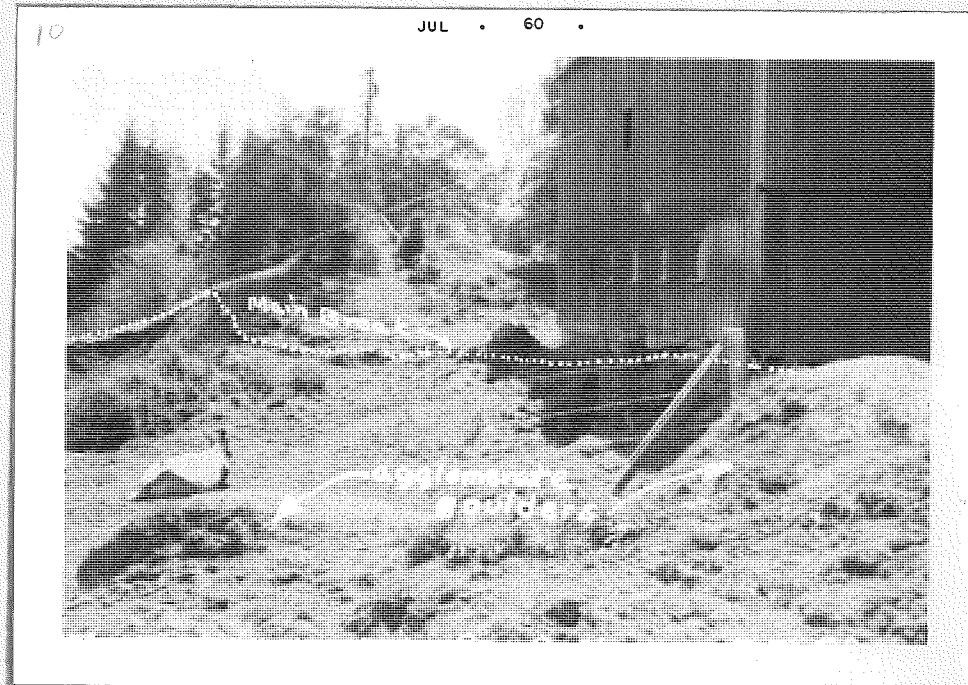
Photographs 11 to 17 show the surface cracks and the settlement and poaching action of the slide and the tension cracks in the old highway left of station 164 to 171.

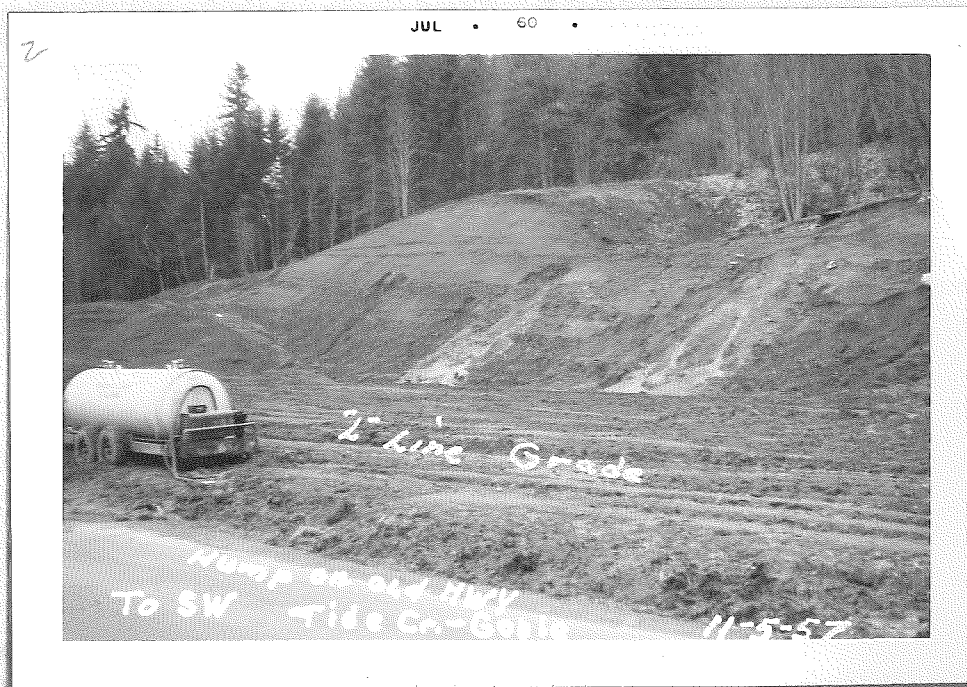
Photographs 1 to 3 show slope failure and excess surface water and horizontal drains as corrective measure.

Photographs 4 to 6 show poaching action and limits of slide in the new roadbed.

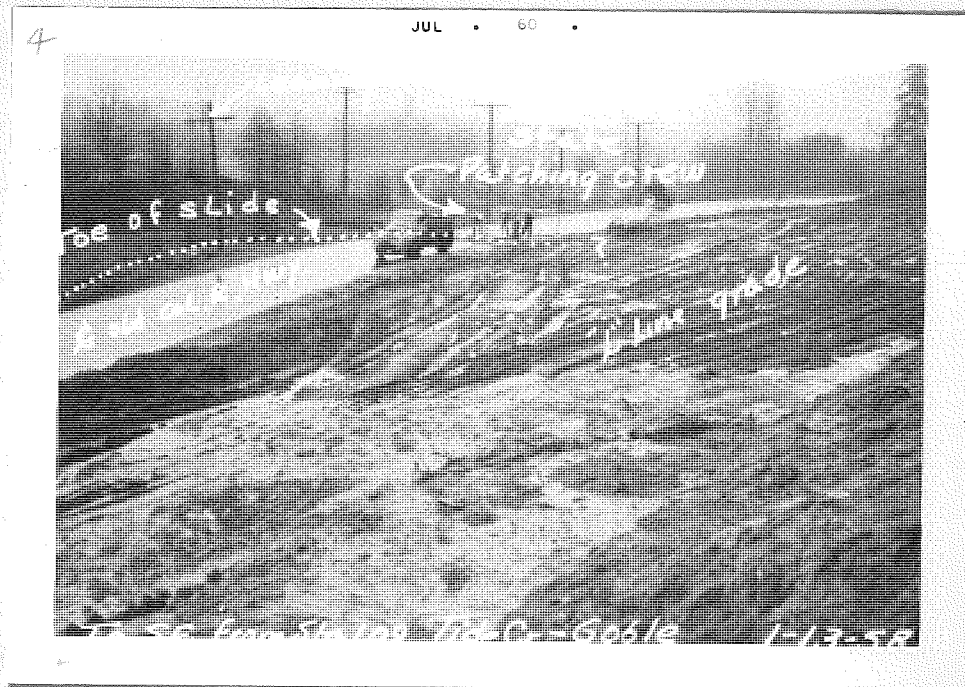
Photographs 7 to 10 show surface cracks, surface water and drainage correction in upper areas of slide approximately 800 feet left of Columbia River Highway.

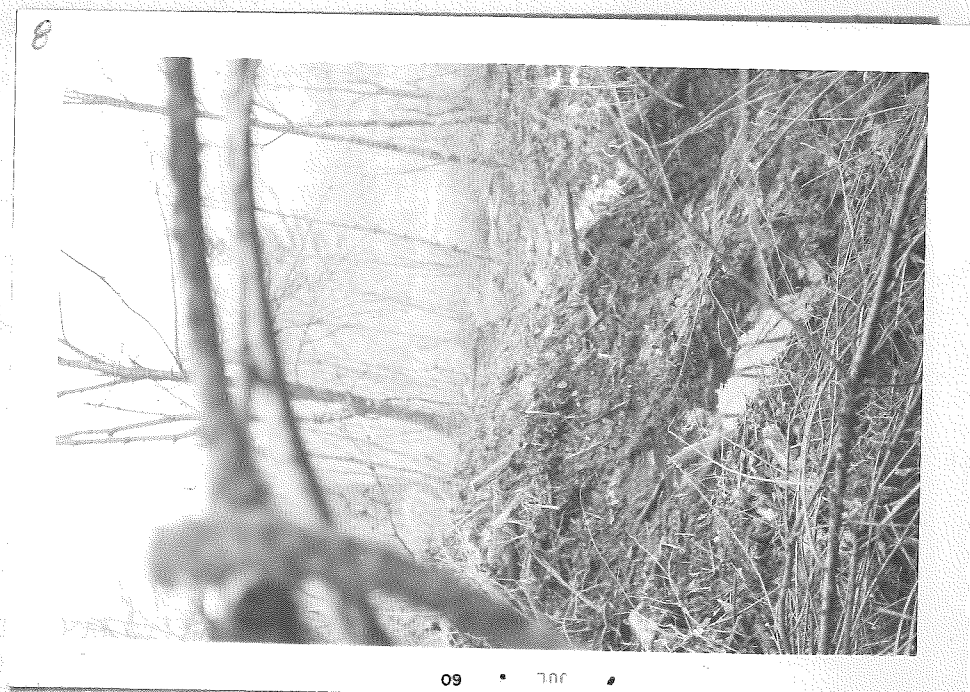
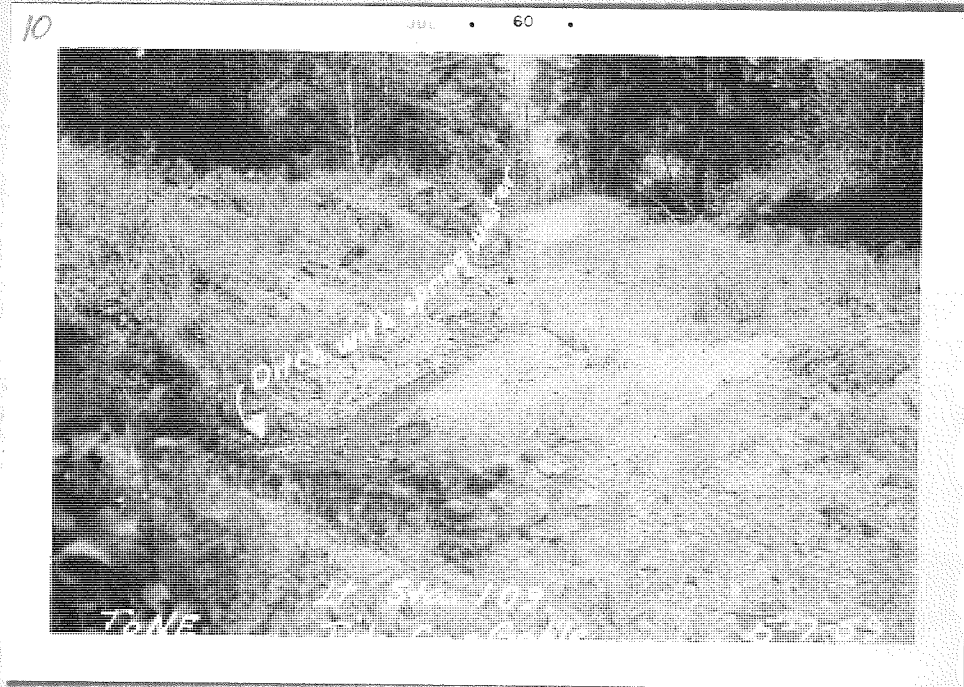
Photograph 11 shows settlement and slide actions in Tide Creek Road approximately 1,000 feet left of Columbia River Highway.
